# Mapping Park Maintenance Disparities Across Johannesburg's Socio-Economic Landscape: A Pilot Assessment Study

*Abdulrasaq Ajadi Ishola, Trynos Gumbo, Tafadzwa Clementine Maramura*

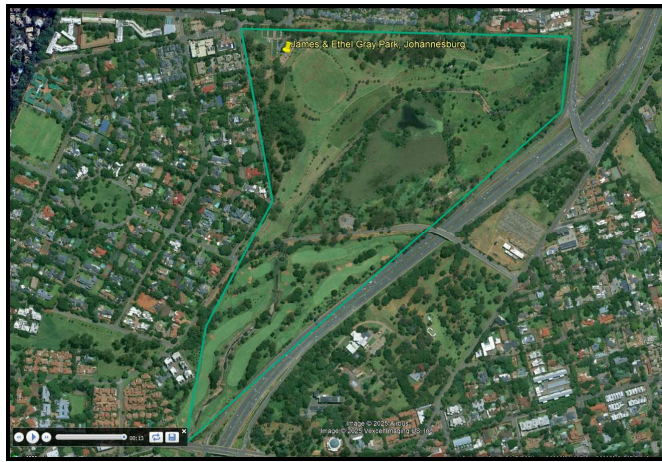
Figure 2: An Aerial view of James & Ethel Gray Park and its neighbourhood. Source: Captured by the Researcher using Google Earth Pro.

The assessment of satellite imagery in Figure 2 showed that the park occupies an area of about 467,819m<sup>2</sup>, making it one of the biggest parks in the city. This wide area enables the park to incorporate many recreational sports, such as golf, long tennis courts, etc. Furthermore, the image showed significant vegetation coverage, creating lushness not only in the parks, but also in the neighbourhood. Vegetation health assessment from satellite imagery showed vibrant green coloration across the park, indicating healthy, well-irrigated vegetation with tree canopy coverage exceeding 40% of the park area. In complementing these, images combined in Figure 3 showed available facilities for enhancing the comfort of the park users, such as car parking, clear boundaries, and without any indication of encroachment.

The combination of the researchers' assessment and satellite imagery evaluation positioned the James & Ethel Gray Park as a well-maintained park, serving park users effectively. Interpreted through the EJ framework, this park exemplifies the distributive justice dimension: it benefits from both municipal investment and private community capital (via the foundation), producing a compounding advantage for an already affluent area. This pattern aligns with Venter et al.'s (2020) 'Green Apartheid' thesis, whereby historical inequalities are reproduced through differential access to both public and private environmental resources. The park's profile thus illustrates how structural privilege is materially encoded in urban green space.

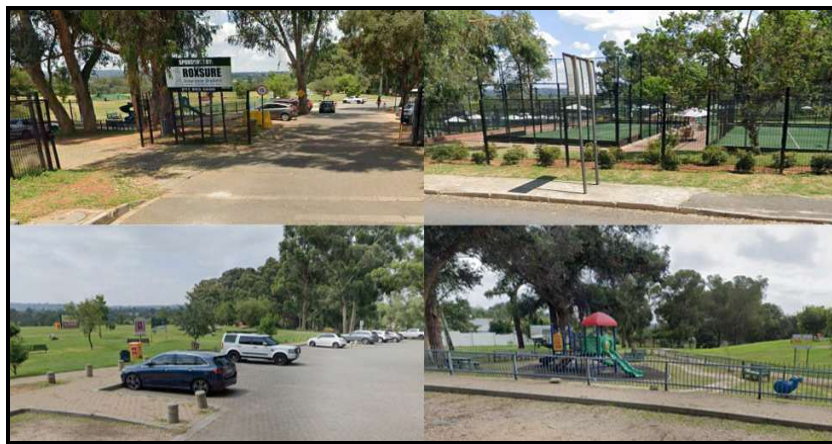
Figure 3: A Cross Section of the Scenery at the James & Ethel Gray Park.

In this park, all assessors found that the park infrastructure was adequate, and the recreation amenities included facilities suitable for kids and adults. The park surroundings are also clean and well-fenced to safeguard both the property and the lives of the park users. Evidently, in Figure 2, the park is situated in a well-organized residential community with lush green vegetation. This finding shows that this park meets the four criteria (i.e., infrastructure, amenities, maintenance, and safety) adopted in the assessment. The researchers also noticed an indication of community partnership with municipal officials in the maintenance of the parks through the establishment of the James and Ethel Gray Park Foundation (<https://jamesandethelgrayparkfoundation.org/>), where people are encouraged to support the maintenance of the park with donations.

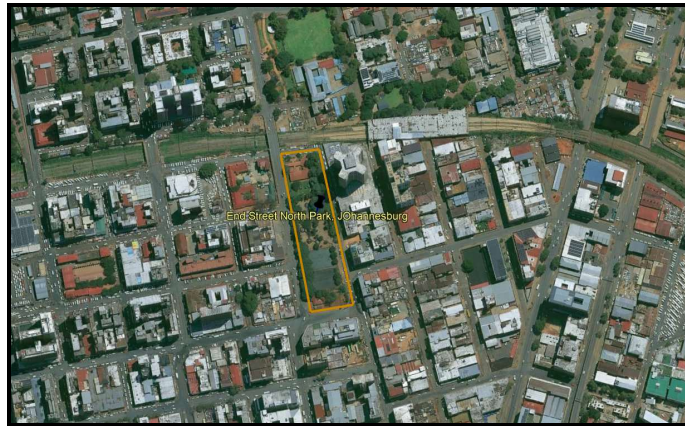
Figure 4: An Aerial view of End Street North Park, and its neighbourhood. Source: Captured by the Researcher using Google Earth Pro.

This park is located at the centre of the city where residential and business buildings intersect, as shown in Figure 4. In the assessment of the park, it was found that the location of the park exposes it to encroachment from homeless people, who lodged around the perimeter of the park, despite it being well-fenced. Within the perimeter of the park, no significant infrastructure was noticed aside from the adjoining buildings that looked like municipal office buildings sharing space with the park; however, about four recreational facilities were seen, mainly for kids. Despite the encroachment, the park environment is well-maintained without any

The satellite image showed that the park occupies a relatively small land area of 14,366m<sup>2</sup>, and within this space, two municipal buildings are positioned on either side of the park. From a spatial justice perspective, this park's condition demonstrates what Buchholz (2011) identifies as 'unjust geographies': the park is maintained for reputation rather than residents' welfare, representing a form of procedural injustice where maintenance decisions are driven by the municipality's image management rather than the recreational needs of the surrounding community. This performative maintenance, cleaning for visibility rather than function, illustrates a superficial compliance with EJ distributive norms that masks procedural and recognition failures.

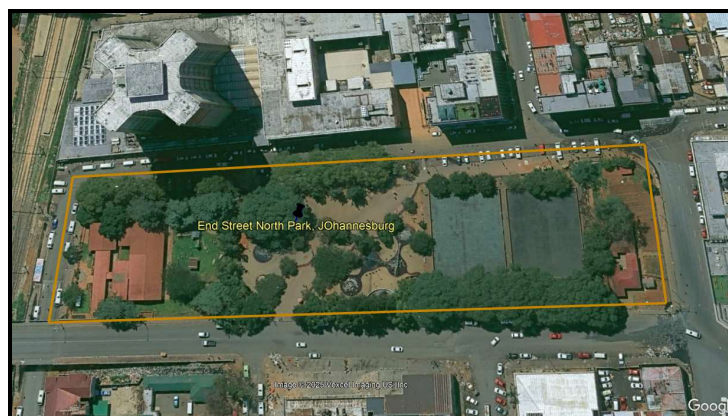
Figure 5: A close look at the End Street North Park.

visible graffiti or damage. This cleanliness is assumed to be due to the location of the park in the city centre, where its status can be easily noticed and thus poses a likely damage to the reputation of the city.

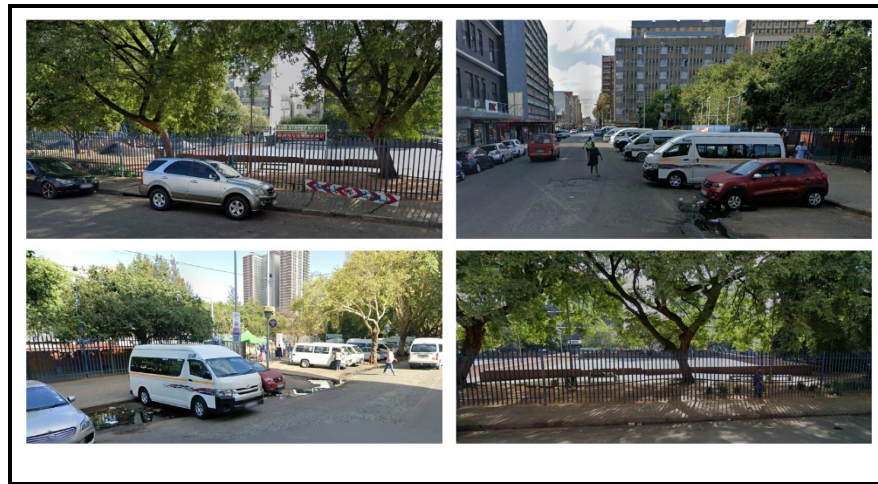
Figure 6: A Cross Section of the End Street North Park Scenery.

Given its location, adequate parking spaces are lacking, and the available spaces have been encroached by Taxis that have adopted the space (see Figure 6) as an informal park station. This limits the extent of the safety of cars belonging to park users. Going by the adopted indicators, the End Street North Park is limited in infrastructure, recreation amenities, and safety, even though it is well-maintained. It is because of these observations that the park is categorized as fairly maintained.

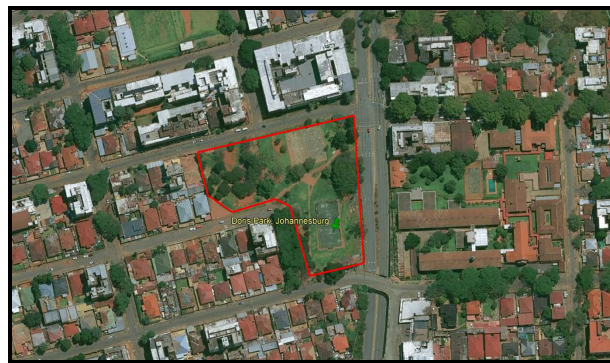
Figure 7: An Aerial view of Doris Park in its neighbourhood.

An assessment of the satellite image indicated that the park occupies 12,636m<sup>2</sup> of land. It is in a low-income neighbourhood, populated mostly by foreigners. The community streets were littered with waste, dilapidated houses, and evidence of street dwellings. Satellite imagery shows vegetation present, but with irregular distribution and evidence of stress. This pattern resonates with Shackleton and Gwedla's (2021) observation that vegetation stress is disproportionately concentrated in historically disadvantaged neighbourhoods, a legacy of apartheid-era green infrastructure underprovision. The Doris Park case represents the most severe expression of recognition injustice: the community's needs are rendered invisible by municipal governance, and the park's informal appropriation by vulnerable populations is a symptom of deeper spatial exclusion rather than community agency. Addressing conditions at Doris Park therefore requires more than physical

reconstruction; it necessitates recognition of the social drivers of the park's current state within broader equity-oriented urban governance reform.

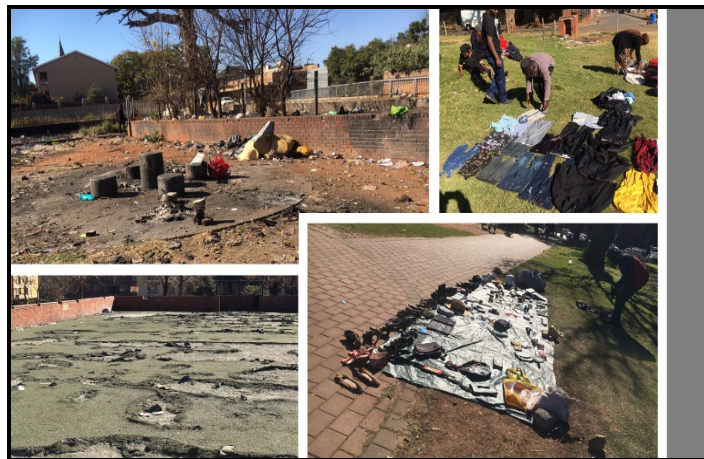
Figure 8: A Cross Section of the Scenery at the Doris Park, Johannesburg.

Doris Park is in Barnato Street of Yeoville, an inner city in Region F, and is characterized by diversity, with residents from multiple nationalities. This disparity, coupled with the economic status of most residents, created a kind of urban slum around the park (see Figure 7). Informal recyclers and homeless people clustered around the dilapidated park facilities. As shown in Figure 8, the basketball court is in shambles, and the surrounding area is littered with makeshift bedding belonging to the homeless, recycled items, indications of fecal contamination, and evidence of waste burning. Furthermore, the park is used as a commercial hub where people display and sell wares, such as clothes, electrical appliances, and related accessories. The park lacks perimeter fencing or any form of infrastructure or protection. Available facilities were open spaces for people to play football and basketball, away from the damaged court.

This park failed to attain any of the assessment indicators. Clearly, there is nothing that warrants maintaining at the park; rather, it requires a complete reconstruction. Lastly, the park environment is unsafe, given the concentration of informal economic activities and visible environmental contamination.
