# Architectural Rehabilitation of Charasteen Cave in Duhok: A Locally-Led Accessibility and Heritage Intervention within the UNESCO–EU MADAD Framework with Support from the Kurdistan Regional Government

*Mahmood Albrifkany*

(Dr. Mahmood Albrifkany, Nawroz University/ Faculty of Engineering/ Architectural Engineering Department, Duhok, KRI, Iraq, mahmoud.muhammed@nawroz.edu.krd)

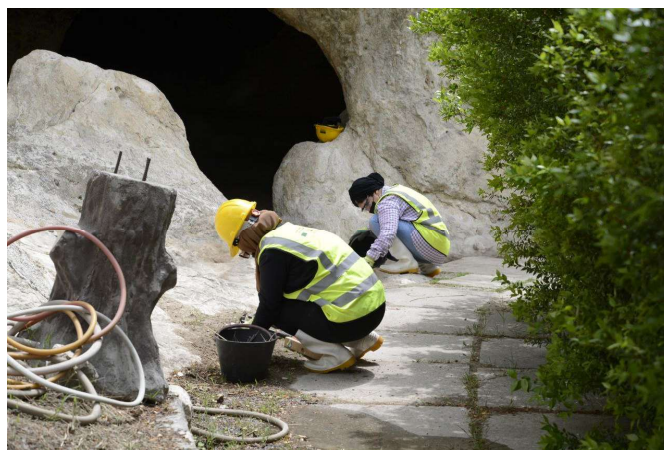
Fig. 2: Women cleaning the Charsteen's external surfaces from the grass.

The use of an Employment-Intensive approach (in accordance with ILO guidelines) allowed for the involvement of women, refugees, internally displaced persons (IDPs), persons with disabilities and members of the local community through the provision of Cash-for-Work programs (as shown in Figure 2). Manual building techniques enabled social inclusion while allowing for detailed, heritage-specific rehabilitation.

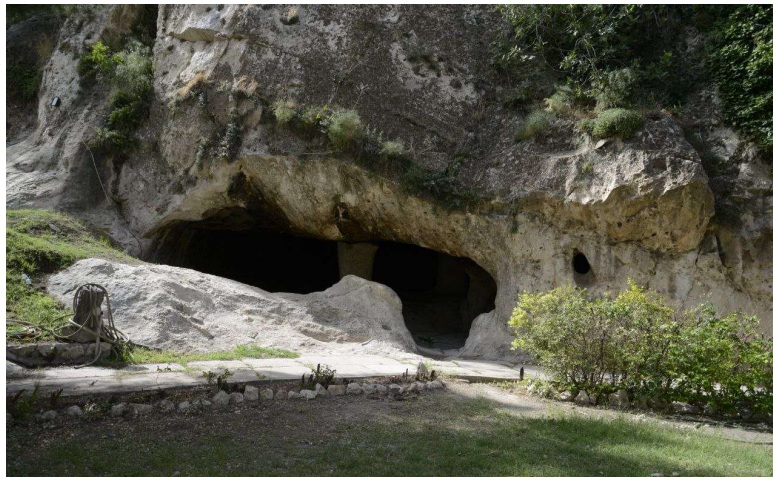
Fig. 3: Entrance of Charsteen cave (4 pillars).

The Charsteen (cave Char-Steen) archaeological site is located in the city of Duhok, in the Kurdistan Region of Iraq. It is near the Duhok dam and is situated where the Dohuk river meets the White Mountain range. Historically, this location served as a sacred Zoroastrian worship place. The site represents a symbolic representation of water, earth, air and fire. “Charsteen” is the Kurdish word for four pillars. Remains found at the archaeological site show evidence that it was used as a fortification during ancient military campaigns. Due to the natural environment and the flow of water, the site requires careful treatment to prevent environmental damage. The site is known as one of the most significant cultural historic sites in the area of Duhok and has been restored through a collaborative effort from UNESCO, the WADI organization, the Directorate of Antiquities and Heritage of Duhok (Government of Kurdistan), and the European Union. The site includes an ancient temple carved out of rock, known as the Charsteen temple (see Figure 3). This temple has been dated thousands of years old and contains four natural rock pillars and a recently restored temple (known to be Zoroastrian) and is thus a major historic and tourism destination. In addition to the cave (temple) the site also includes an Anahita canal, open fire temple, rock fire, fire altar, fire temple, Anahita temple, tomb, cave, tunnel, simiting place, juicer, and is encircled by a fence (Nhili, 2022).

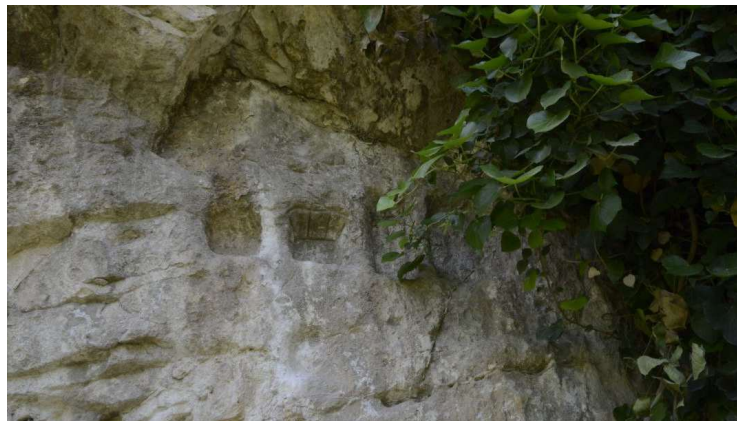
The assessment found significant quantities of dense vegetative growth throughout circulation paths and on the outside of the cave, as shown in Figure 5. Using characteristics of leaves; growth patterns; and local environmental factors, the primary climbing and groundcover species was identified as *Hedera helix* (English ivy). While *Hedera helix* provided positive effects such as improved erosion resistance and microclimate stabilization, it also created negative impacts by obscuring the cave's entrance, signage, and interpretive features thereby limiting visibility and way-finding. This information directly influenced the need to provide for specific clearing and controlled vegetation management efforts and not total removal.

Fig. 5: *Hedera helix* (English ivy) covers symbolic representation of water, earth, air and fire, and the exterior surfaces of the Charsteen Cave.

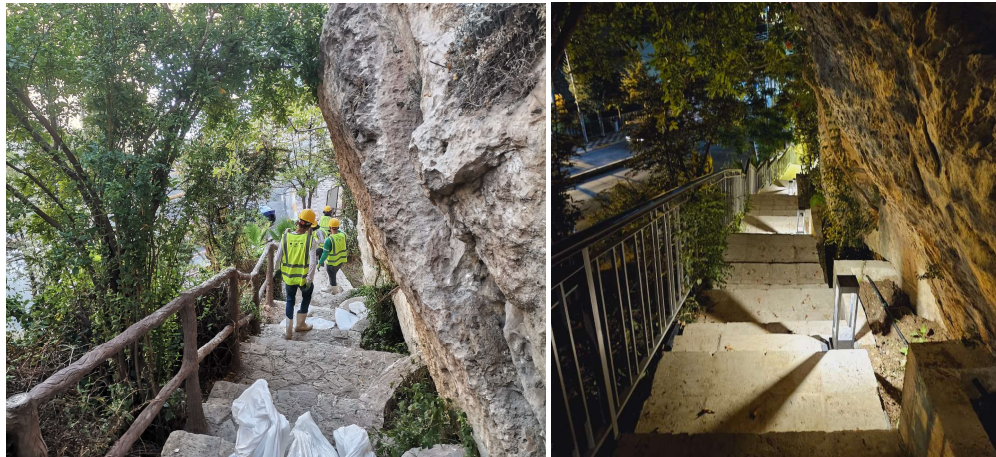
Fig. 7: Stone stairs. The before and after intervention.

The pavement and tiling works were coordinated closely with the Duhok Directorate of Antiquities. A detailed review of the Bills of Quantities (BoQs) against site conditions was undertaken to resolve technical issues and to modify designs where necessary, as can be seen in Figure 7. The excavation, sub-structure construction and installation of durable, safe, and compatible to the heritage fabric pavement systems were completed to provide improved access for visitors to the cave, while preserving the visual and cultural integrity of the cave.

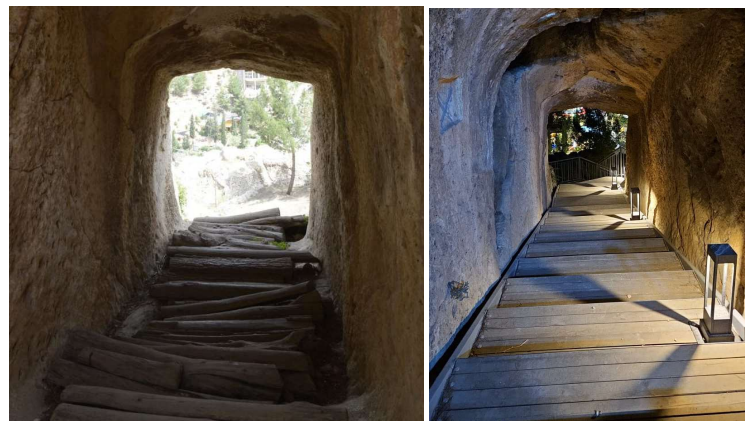
Fig. 8: Tunnel. The before and after intervention (iron and timber).

Steel works involved the design, manufacture and construction of handrail components, staircase and floor structural framing, benches, waste recycling containers, shade structures, stainless steel safety chain systems and signage systems (Fig. 8), that were constructed in compliance with regulatory requirements regarding both functional performance and safety, while visually being non-obtrusive. The wood works provided functionality and compatibility by installing stair treads, flooring, roofing and gabion-timber elements treated to ensure longevity under various environmental conditions and maintaining their natural appearance.

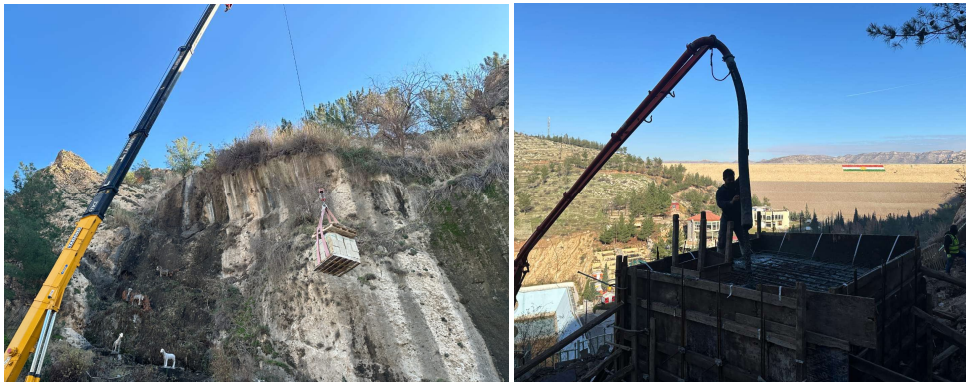
Fig. 10: Transporting materials and fittings and casting concrete for the water tank using a crane and a pump poster.

Infrastructure improvements for this project included careful planning to protect sensitive areas by creating a new water supply system, sewage, water recycling, and electrical systems. Local and small-scale trenching with materials that are suitable and compatible with the environment/heritage area was done to minimize environmental and heritage impacts, increase durability and enhance visitor comfort and site resilience (Syriacpress, 2025). Materials such as plumbing fixtures, electrical components and construction materials were brought up to the top of the mountain, and a pump booster was utilized in order to cast concrete to build the water tank, as shown in Figure 10.

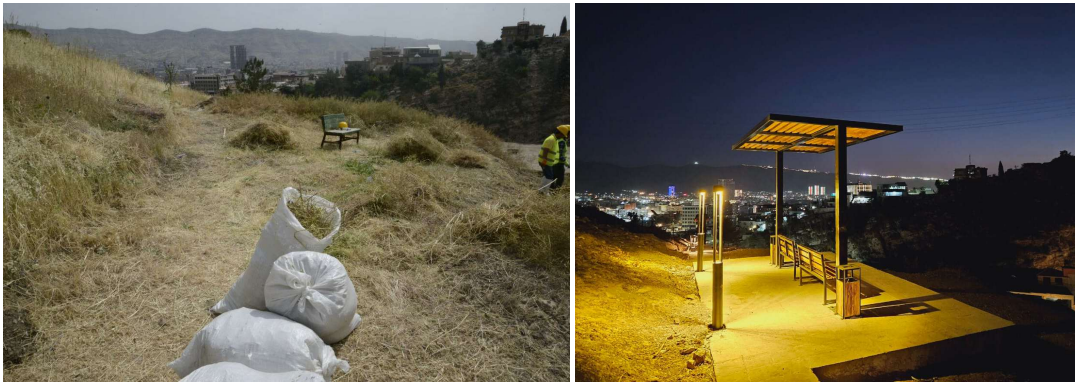
Fig. 11: Creating covered rest places which situates on the west side of the cave (Before and After intervention).

The adaptive reuse strategy is about the rehabilitation or repurposing of previously used structures for new uses, with the goal of conserving structural elements while protecting historic architectural characteristics and extending the useful life of the location (Albrifkany et al, 2021). The rehabilitated areas at Charsteen Cave now house rest points for visitors, storage for tools, maintenance facilities, and educational stations. The overall purpose of the project was to have a reduced ecological footprint while increasing usability of the site. This involved creating both covered and uncovered rest places, as shown in Figure 11, as well as an open-platform stage for cultural events utilizing a stone masonry seating platform, timber kiosks and rest areas adjacent to the tunnel, and a complete water distribution system that would provide irrigation to all landscaping elements (shrubs, grasses, etc.). Restrooms are located in the reception area and in proximity to the open-stage. The irregularly shaped natural rock stepways were replaced by a series of regular local limestone stairways and two sets of steel stairways were installed to allow visitors to transition between the archaeological stairway and the limestone stairway. Minimal amounts of steel were utilized in order to minimize intervention to the site and protect it. Several pathways were created utilizing iron and clad with wood to protect the rocky surfaces.

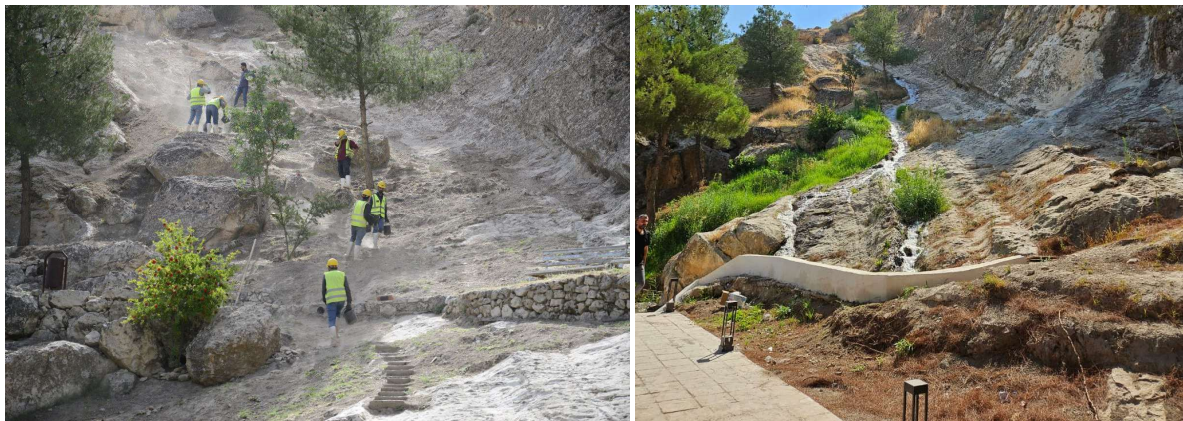
Fig. 12: artificial waterfalls that had been relocated approximately 100-200 meters away from the cave to further minimize the effects of this aspect on the entrance cave's surfaces (Before and After intervention).

A water collection tank was developed to allow recycled water to be used from artificial waterfalls that had been relocated approximately 100-200 meters away from the cave to further minimize the effects of this aspect of the project, as shown in Figure 12. Ground cover, shrubs, and trees were planted as part of the landscaping aspects of the project. Signs in three languages (Kurdish, Arabic, and English) were also designed and installed as part of the project. All water, sewage, and electric systems were carefully routed away from archaeological areas with approval from Duhok DoAH Supervisors, and documentation was maintained to assist with future maintenance needs. Overall, the adaptive reuse projects at Charsteen Cave have extended the functional life span of the site while preserving its environmental and heritage attributes.
