Post-Disaster Restoration of Erbil's Qaysariya Bazaar

Mahmood Khayyat, Israa Abdollah, Hana Al-Baldawi, Zena Husham

DOI: 10.48494/REALCORP2026.1081

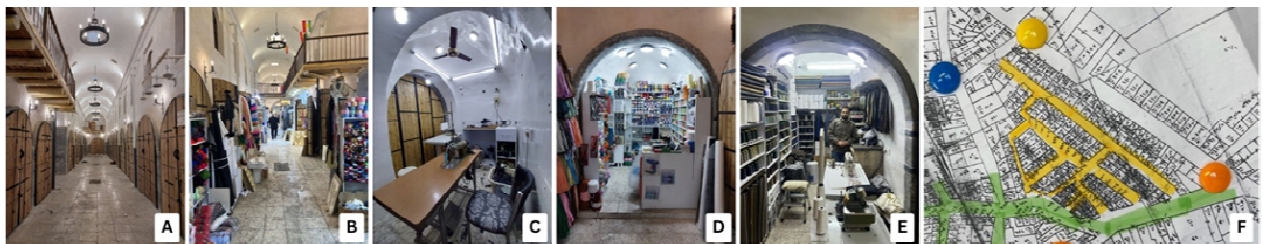
Fig. 1: Panels A and B show the restored interior of the Qaysariya Bazaar, while C, D, and E document the active commercial life within its renovated shops. The map in Panel F illustrates the bazaar's layout, highlighting the streets in yellow and the specific shops that have undergone renovation.

This research examines the renovation process through technical strategies, material choices, service upgrades, and user feedback, highlighting the importance and impact of the work carried out in preserving the bazaar's identity while improving its functionality and safety. functionality, and the well-being of local communities (Fig. 1).
